Investigating Uneven and Very Slow Microplate Evaporation Phenomena

Induka Abeysena, Genevac Ltd

Users in Drug Discovery and life science laboratories, occasionally report uneven and very long drying times in polypropylene microplates when dried in centrifugal vacuum evaporators. This could be due to reasons such as a faulty unit, user error or microplate contamination. This paper describes a series of tests done to identify how microplate contamination can affect the boiling point of samples thereby affecting their drying times.

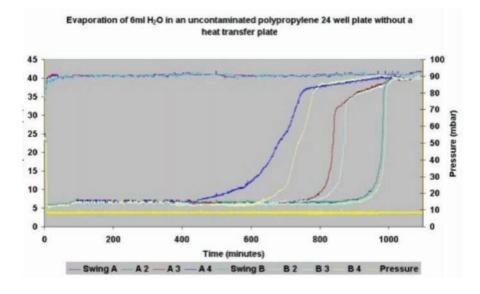
Figure 2

Microplates from manufacturer M2 (see Figure 2), dried as expected and showed no adverse effects. In this experiment the boiling temperature of water held at about 4°C at 8mbar until the all the water was completely evaporated.

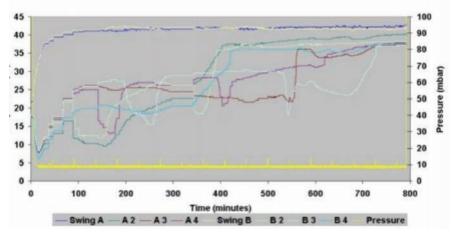
However, in similar experimental conditions, microplates from manufacturer M1 did not dry as expected. Figure 3 below illustrates the volume of water left in each well at the end of the run and Figure 4, shows the graph of the boiling temperature vs pressure curve against time.

The uneven drying of the manufacturer microplate M1, might be explained by contaminant film formation on the surface of the water hindering evaporation. Figure 4 shows fluctuation of the sample temperature at 8mbar. The uneven results indicate that the sample being evaporated was not pure water and that film formation arising from microplate M1 hindered the water evaporation resulting in an elevated sample temperature.

In summary, if such an effect manifests itself, to prevent contamination and long sample drying times, it may be advisable to do some preliminary runs using known pure solvents. If observed drying times are much longer than expected, try washing plates before use. Acetone washing is not always effective, but has proved useful in many cases. Where washing cures long drying times, plate contamination is almost certainly the cause, and another plate source should be used.

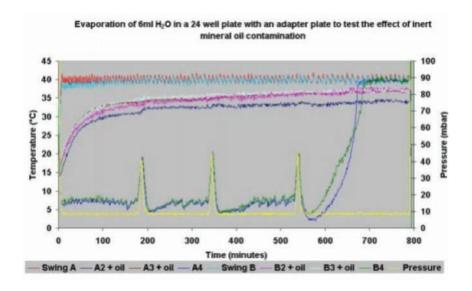
In further experiments to simulate the effect of contamination, we added a small amount of an inert mineral oil to some wells of a microplate from manufacturer M2 along with 6ml of water. Results from this evaporation experiment are shown in *Figure 5* below.

It is clear from a comparison of *Figure 5* (induced contamination) with those of *Figure 4* (genuine contamination) that the effects are similar. The induced contamination gave results closely following those of the contaminated, unwashed plates i.e. they exhibiting elevated solvent temperatures during drying, and left some microplate wells wet. The induced contamination is clearly more severe than that which occurs when using the contaminated microplates from Manufacturer M1. This is likely because the naturally occurring contaminants were present at lower levels that the gross induced contamination.
