Investigating Uneven and Very Slow Microplate Evaporation Phenomena

Induka Abeysena, Genevac Ltd

Users in Drug Discovery and life science laboratories, occasionally report uneven and very long drying times in polypropylene microplates when dried in centrifugal vacuum evaporators. This could be due to reasons such as a faulty unit, user error or microplate contamination. This paper describes a series of tests done to identify how microplate contamination can affect the boiling point of samples thereby affecting their drying times.

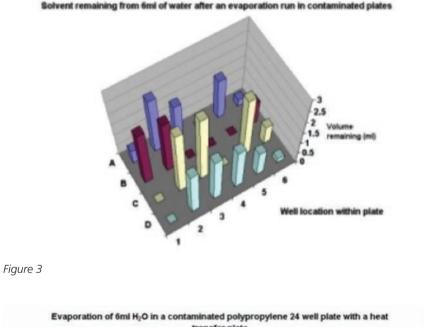
However, in similar experimental conditions, microplates from manufacturer M1 did not dry as expected. Figure 3 below illustrates the volume of water left in each well at the end of the run and Figure 4, shows the graph of the boiling temperature vs pressure curve against time.

The uneven drying of the manufacturer microplate M1, might be explained by contaminant film formation on the surface of the water hindering evaporation. Figure 4 shows fluctuation of the sample temperature at 8mbar. The uneven results indicate that the sample being evaporated was not pure water and that film formation arising from microplate M1 hindered the water evaporation resulting in an elevated sample temperature.

From these experiments we can conclude that microplates from manufacturer M1 were contaminated with a material that forms a film on the water sample surface and acts like a cap to the well, preventing or inhibiting evaporation. This film formation phenomena caused by contamination explains why some microplates exhibit uneven and abnormally long evaporation times.

In summary, if such an effect manifests itself, to prevent contamination and long sample drying times, it may be advisable to do some preliminary runs using known pure solvents. If observed drying times are much longer than expected, try washing plates before use. Acetone washing is not always effective, but has proved useful in many cases. Where washing cures long drying times, plate contamination is almost certainly the cause, and another plate source should be used.
